ANALYSIS OF AVAILABLE SIGHT DISTANCE WITH A PROPOSAL FOR MEASURES TO ELIMINATE DEFECTS

The subject of this Elaborate is the analysis of the available sight distance with a proposal for measures to eliminate deficiencies, on the part of the state road IB number 22, from node 2223 to node 2225. The basis for the realization of this Elaborate was the contract concluded between:

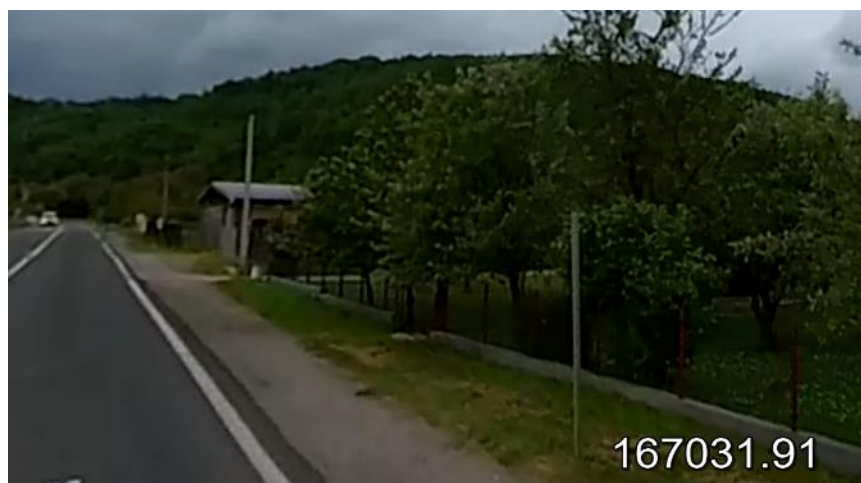
Figure 2 – Pillar on chainage Km~167+040 with a missing traffic sign

Apart from the above, differences in speeds can also occur as a result of missing traffic signs, i.e. signs that have been destroyed over time and have not been restored. This is partly the case on the route in question since it was established that along the route there are cases such as the example in the following picture where at Km~167+040 there is a pillar with a missing traffic sign.

It is assumed that the 50 km/h speed limit termination sign is missing at the location in the previous figure.

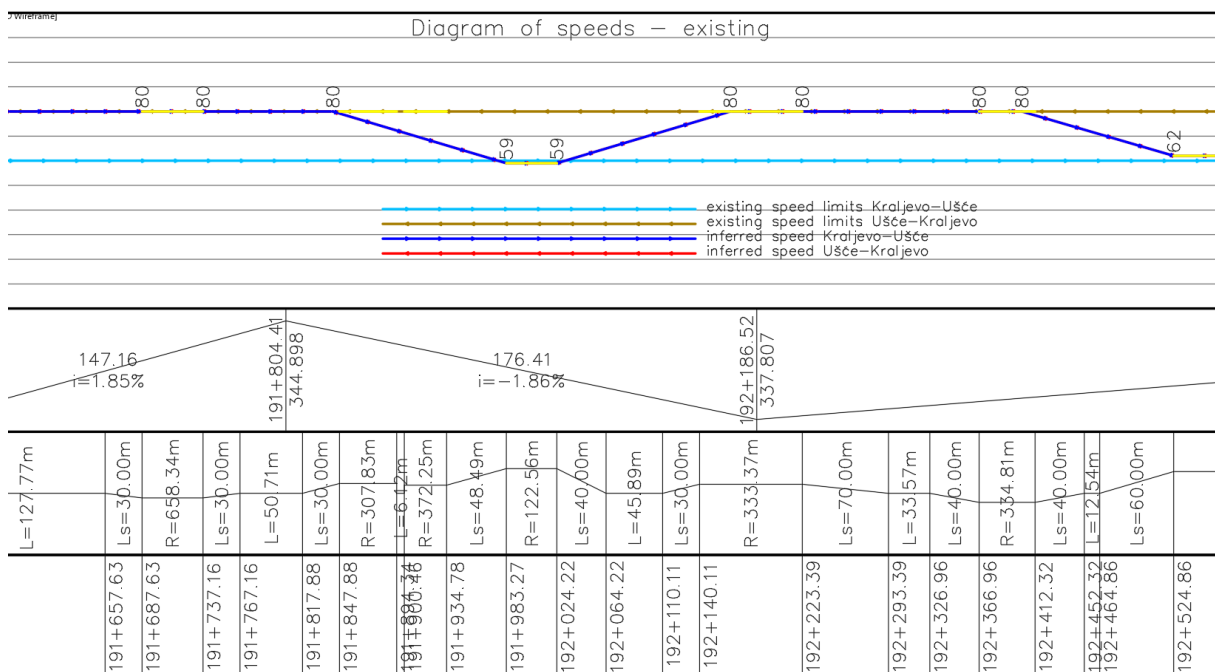
Figure 3 - Speed diagram with examples of "skipped" curves

As an example on which numerous defects of geometry can be diagnosed, we will single out the stretch from Km 191+737.16 to Km 192+024.22, which is shown in the following Figure 3.

Although it is not usual for the inferred design speed diagram, in it only the locations of purely circular curves are marked in yellow and the inferred design speed calculated for those curves is limited to a maximum of $V_p = 80$ km/h, although the curve characteristics in some of them would allow movement and at higher speeds. If we take into account two successive curves $R = 307.83$ m and $R = 372.25$ m from Km 191+847.88 to Km 191+934.78, it can be seen from the inferred design speed diagram that they will be 'skipped'. That is, if the vehicle is moving from Kraljevo towards Ušće, in order to slow down to a tolerable speed of the curve of radius $R = 122.56$ m (Km 191+983.27 – Km 192+024.22, $V_p = 59$ km/h), it is necessary to start decelerating with the defined deceleration

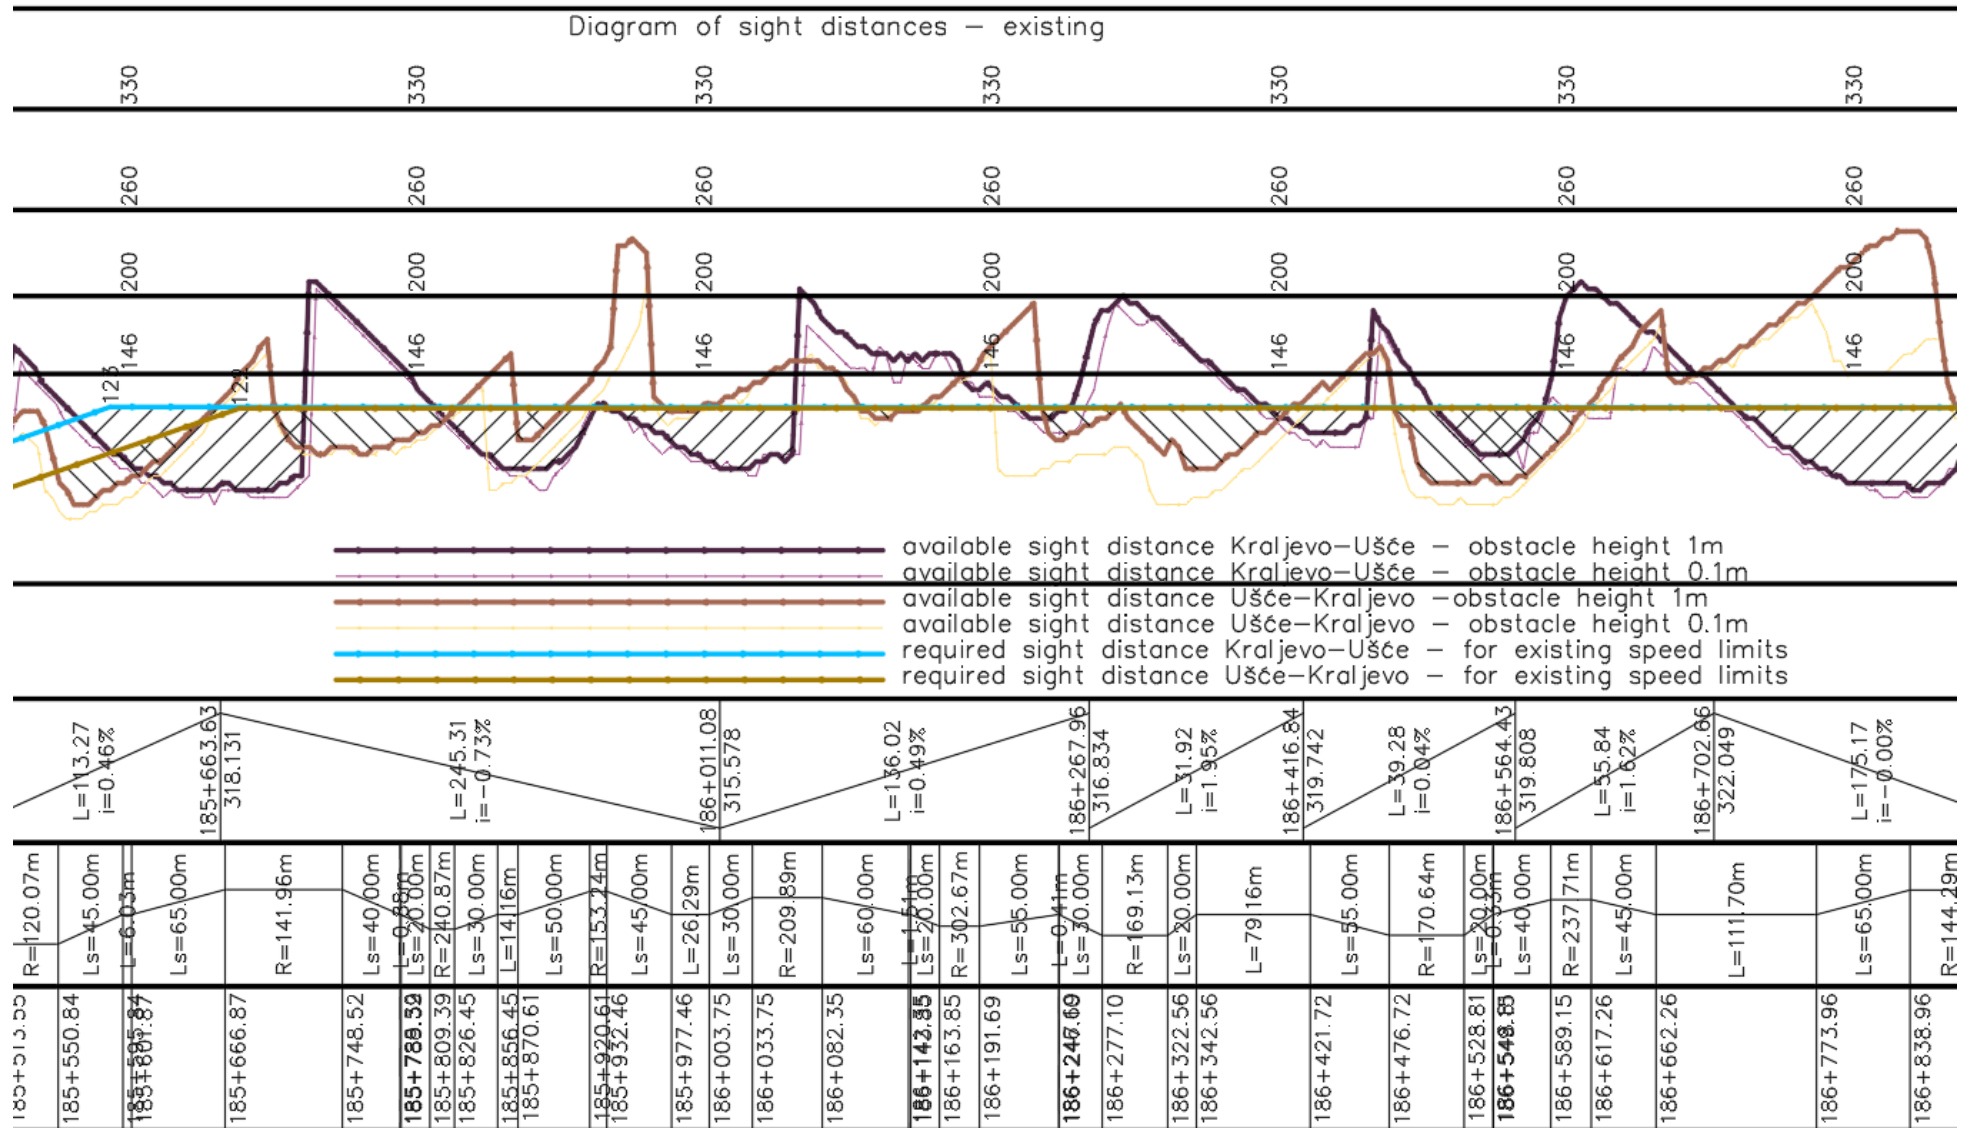
Figure 4– Diagram of sight distance with an example of zones where the required sight distance is not met

By comparing the available sight distance diagrams with the required sight distance diagrams for the posted speed limits, numerous segments can be observed where the available sight distance falls below the required sight distance value. Those segments are certainly significantly more pronounced if the available sight distance for an obstacle height of 0.1 m is observed, compared to an obstacle height of 1.0 m .

In general, it can be stated that on the section in question there are very pronounced problems with the fulfillment of the required sight distance for the posted speed limits, which can cause drivers to misjudge traffic situations and contribute to the occurrence of traffic accidents.

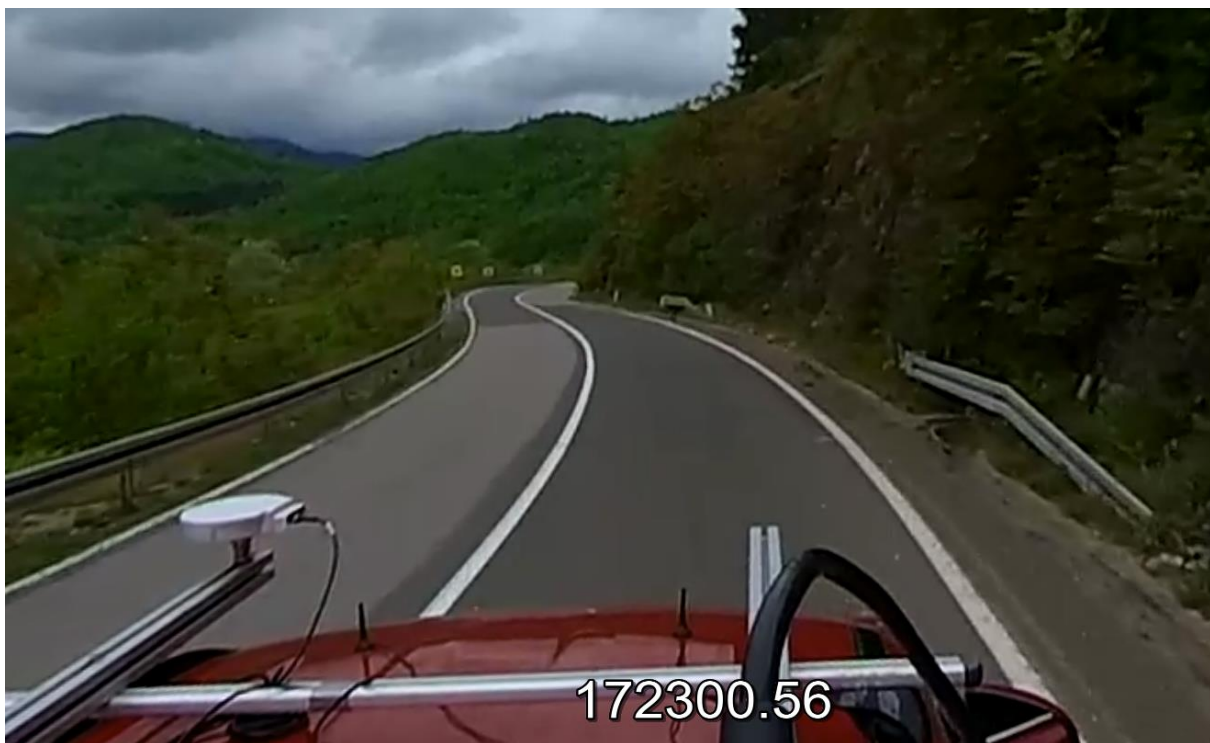
Figure 5 – Layout of the side cut at the location in question

As can be seen in the diagrams, the differences in the proposed speed limits by directions are primarily due to the differences in available sight distance. For example, in the section from Km~172+275 to Km~172+514, the posted speed for the direction from Kraljevo to Ušće is proposed to be 50 km/h, while in the opposite direction it is 60 km/h. This is a consequence of the fact that the available sight distance for an obstacle height of 1.0 m in the direction from Kraljevo towards Ušće drops to a value of 50 m, while in the opposite direction it is a minimum of 70 m. Since the route at this location is located in a side cut with a very steep rock mass on the right, it is not possible at this location to expand the sight distance berm on that side by short-term measures, but it is necessary to limit the speed for the direction in question. The layout of the side cut at the location in question is shown in the following picture.

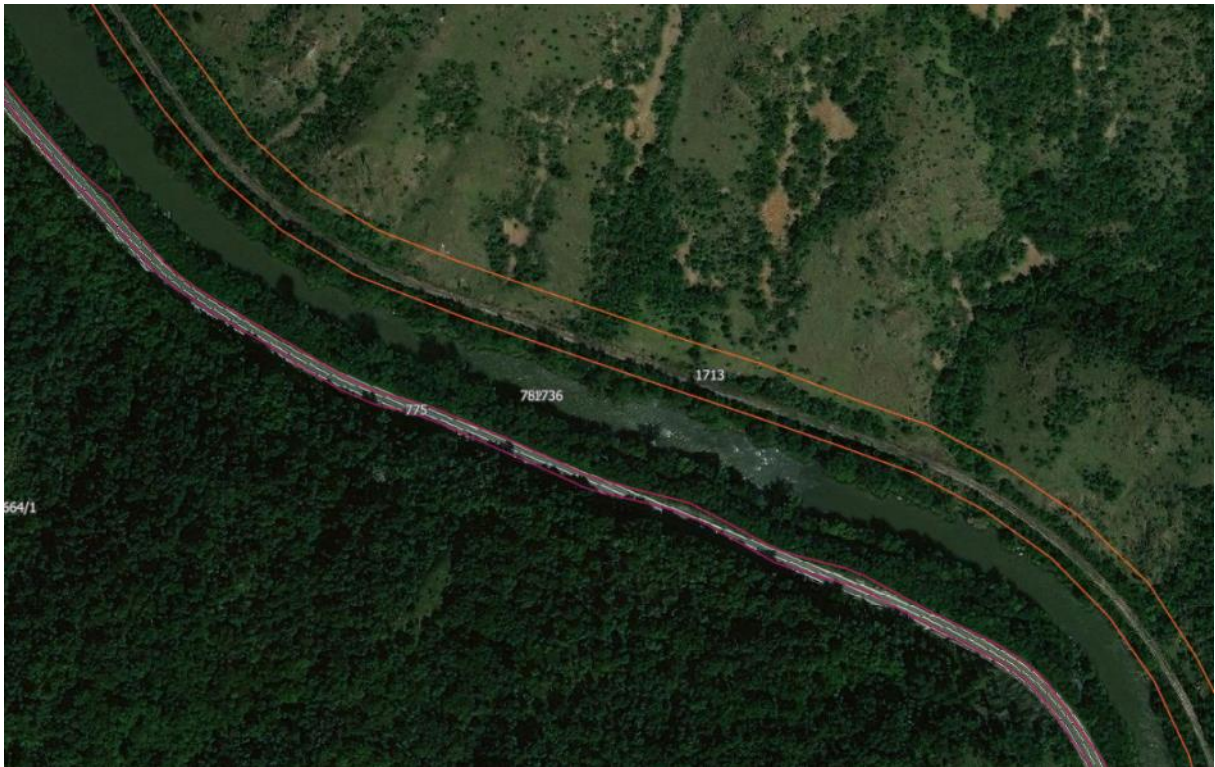
Figure 6 – Layout of cadastral plots in the Km~184+400 zone (K.O. Maglič, Kraljevo)

For the needs of the opposite direction, the sight distance of 330 m opens at the chainage Km 184+769.18 and within the existing condition continues to the chainage Km 184+681.74. However, for this direction, the expansion of the sight distance berm is significantly more favorable because it is obstructed only by the vegetation on the left side of the road, viewed in the direction of the chainage's growth. This disturbance can be eliminated by cutting the vegetation through short-term measures. At this point, the question arises to what width it is meaningful to remove the vegetation and open the berm for sight distance. The answer to this question is not simple and is usually directly dependent on property-legal relations, i.e. the border of the road belt. However, along the section in question, the road plot is mostly bordered by water land, that is, in both cases, the state is the owner and there are no restrictions on clearing vegetation as in the case of private owners. Figure 6 shows the cadastral plots (KO Maglič, Kraljevo) in the subject zone taken from the Geosrbija web portal.

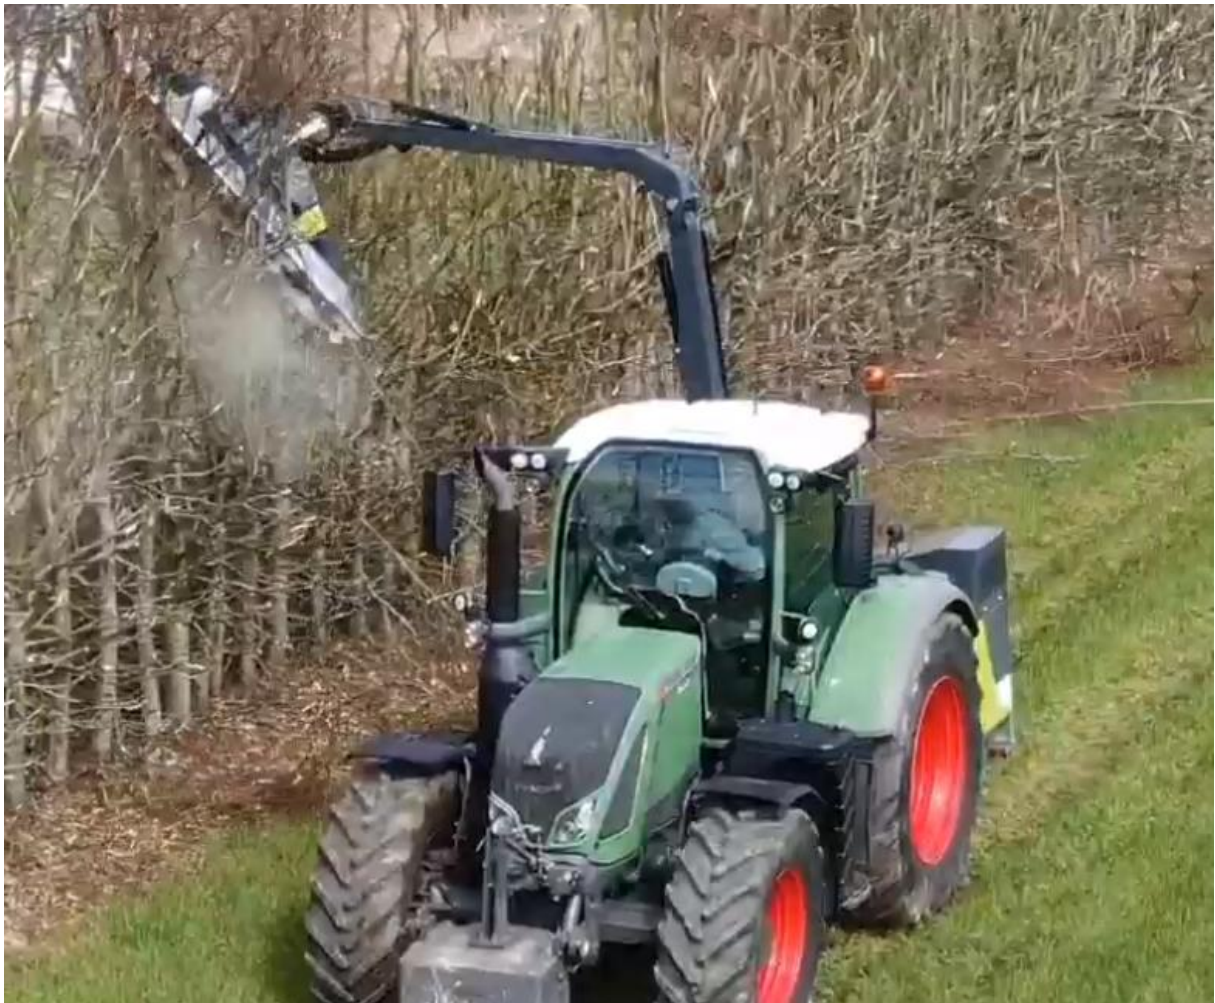
Figure 7- Example of a machine for cutting vegetation in the service of road maintenance

After consultation with the representatives of PE Roads of Serbia, Road Maintenance Sector, the position was taken that the width of 6-7 m from the edge of the roadway can actually be considered as a rational width in which it is justified to expand the sight distance berm in such conditions, and it

refers to the effective working width of modern machines for cutting vegetation along the roadside. The Figure 7 shows one such machine.

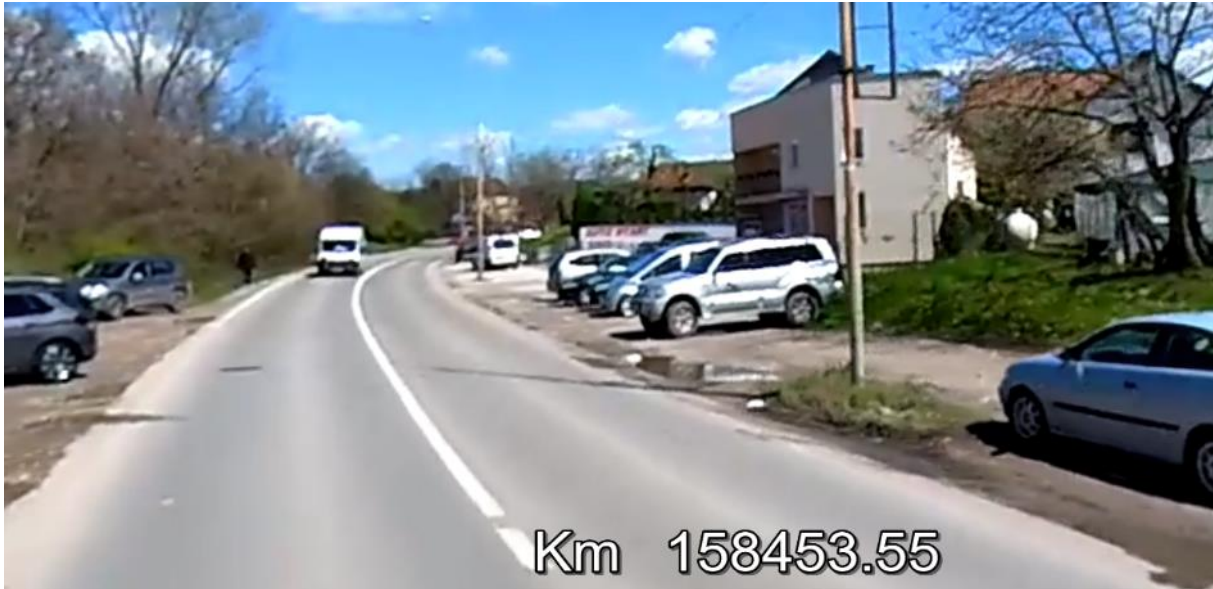
Figure 11- Parking on the inside of the curve on unplanned and unorganized surfaces

A frequent phenomenon along state roads in the Republic of Serbia is the positioning of parking lots/rest areas on the inner sides of curves, precisely in places where such facilities obstruct sight distance. The problem of parking/stopping is particularly pronounced in urban areas, where it also happens on areas that are unorganized or not even planned for that purpose. One such example is shown in the pictures Figure 11i Figure 12.

In such locations, it is necessary to either prohibit temporary/permanent stopping/parking of vehicles or limit overtaking.
